How to Sell the Project

Background-Big Stone Facility

Background-Stevens County Facility

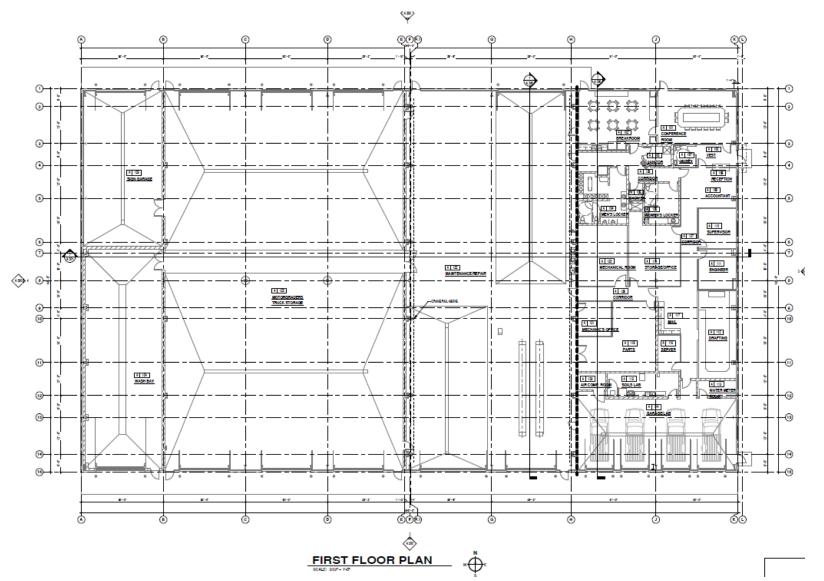
WEST ELEVATION

Office 60 ft x 140 ft, including a materials lab and engineering garage, 8,400 sq Ft

Shop 60 ft x 140 ft, covered by 10 ton OH crane, pull thru bay and parallelogram lift, 8,400 sq ft

Wash Bay 80 ft x 30 ft, fits tandem truck with D6 on trailer, 2,400 Sq Ft

Warm Storage 90 ft x 140 ft, 12,600 sq ft

Sign Shop 60 ft x 30 ft, 1,800 Sq Ft

Total 33,600 Sq Ft, not including the cold storage building.

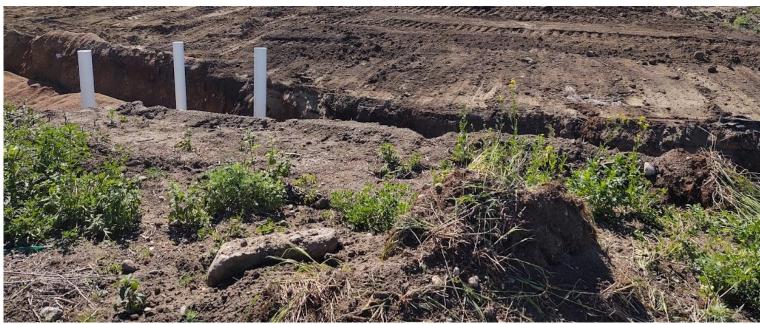
Big Stone Sediment Pond

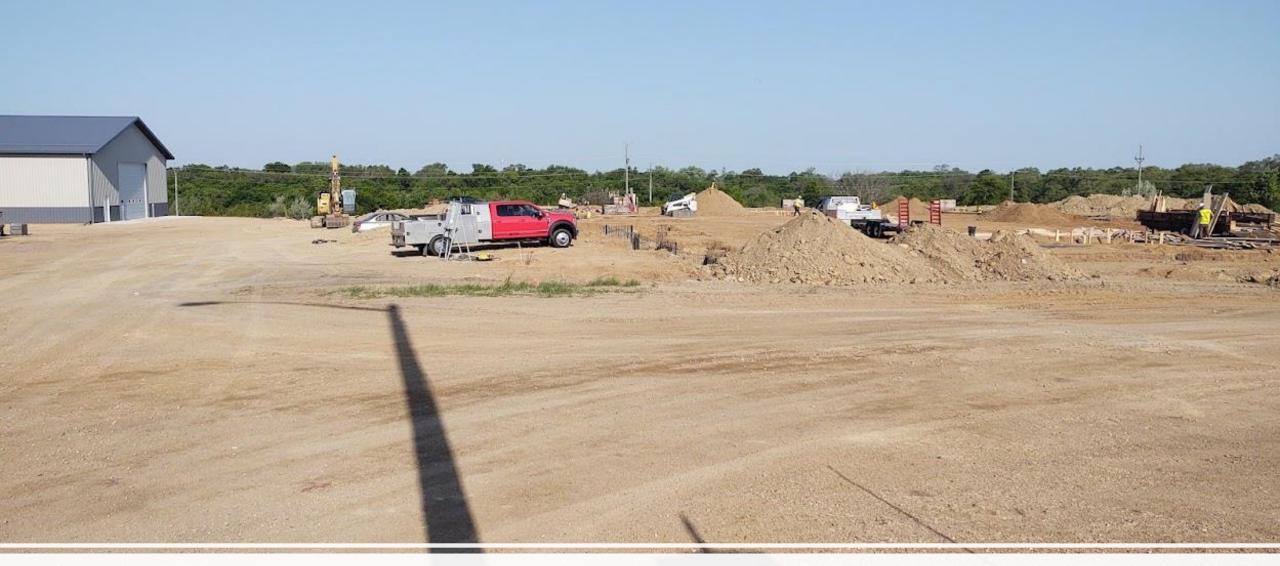
Big Stone Site, footings

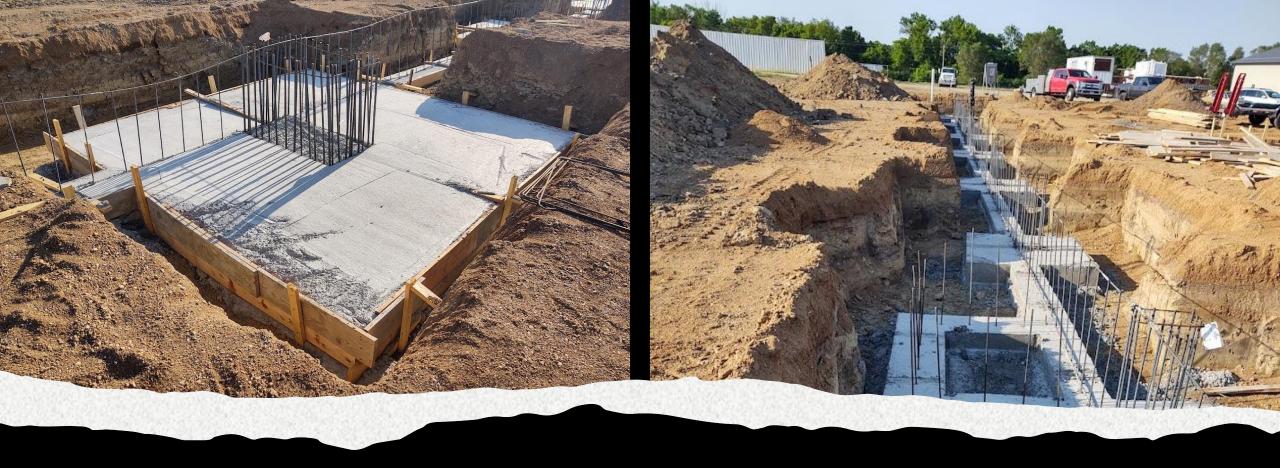
Footing Wall and Pier Footing

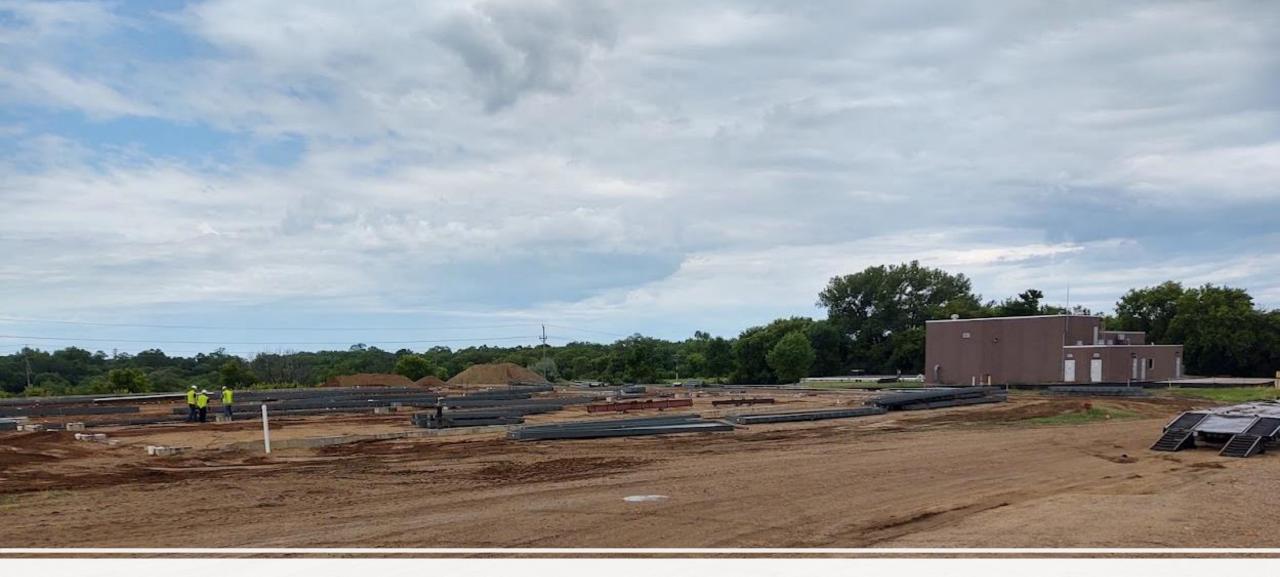
Steel Frame Laid Out

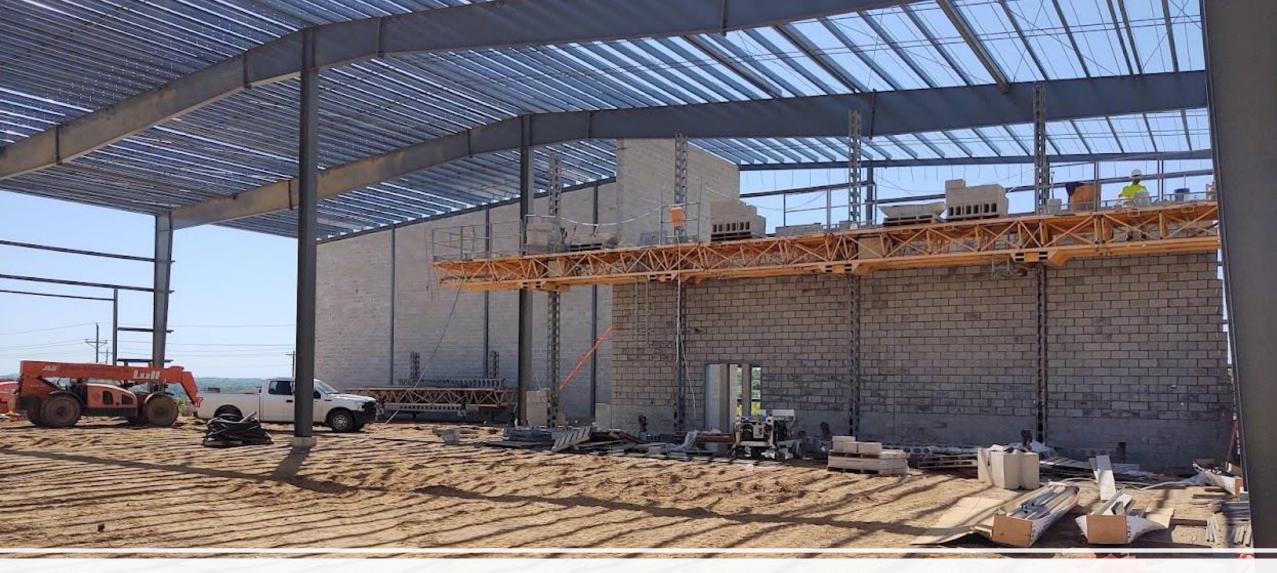
Concrete Masonry Walls going up

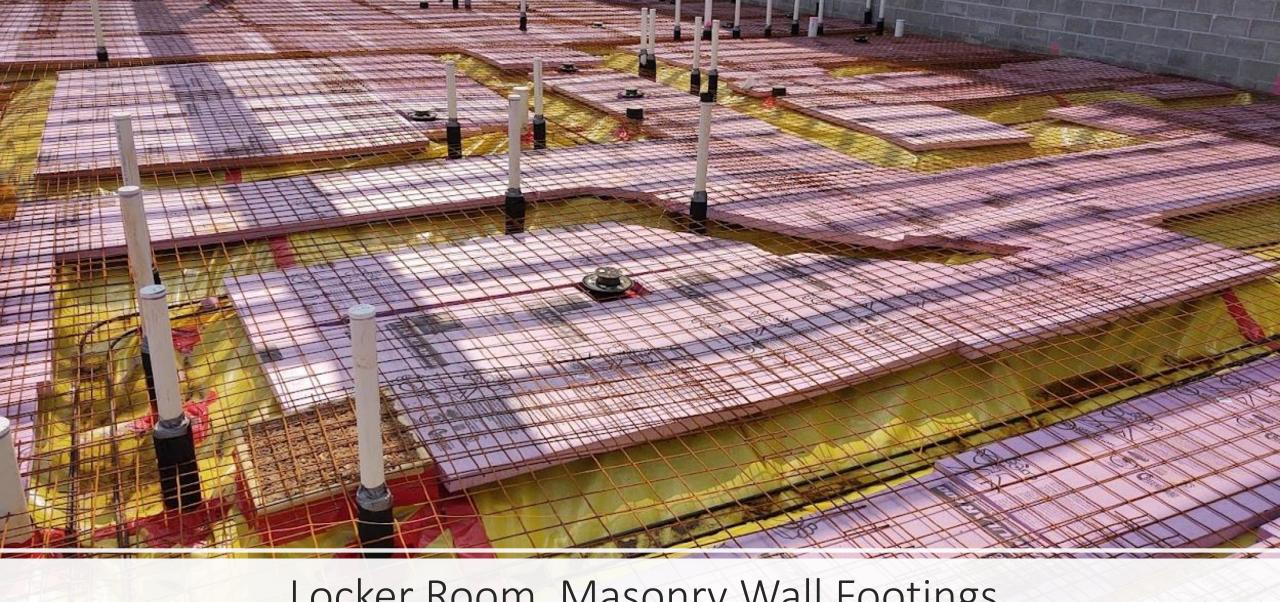
Locker Room Masonry Wall Footings

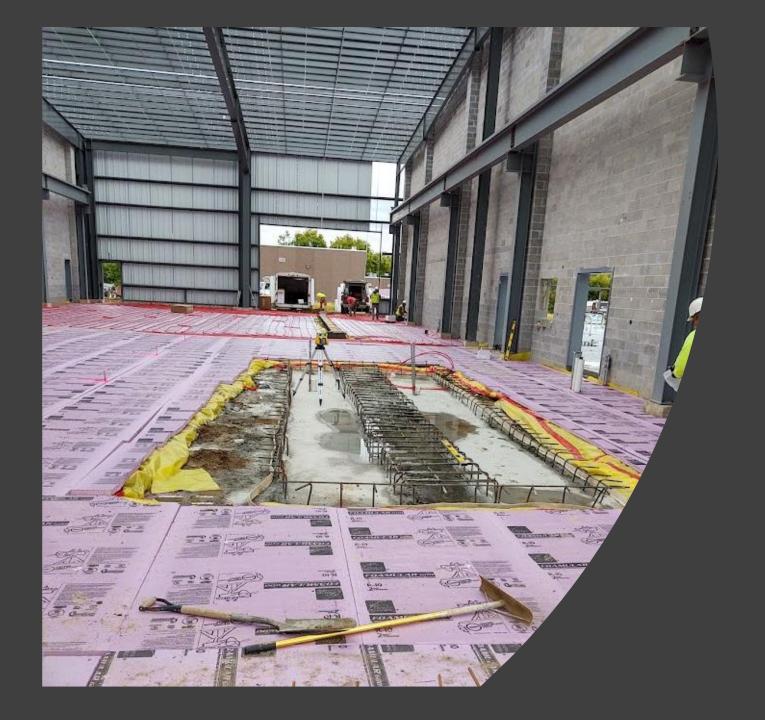
Parallelogram Lift Footing

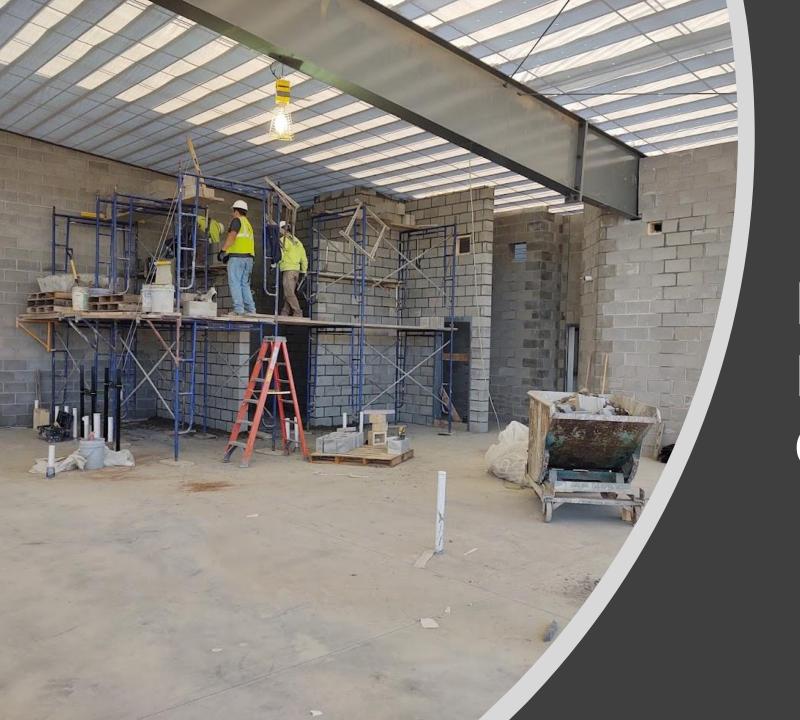
Interior Masonry Walls Going Up

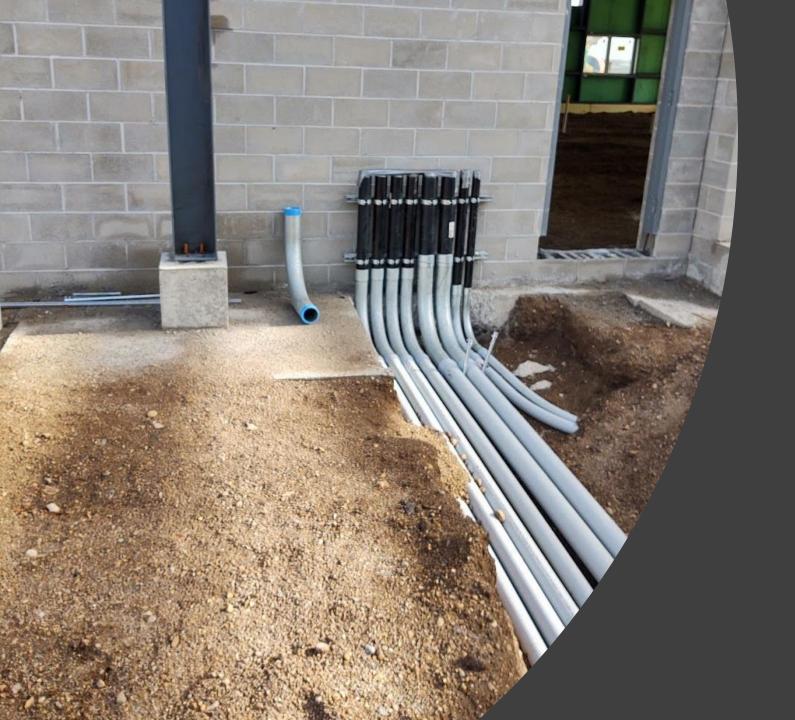
Plan for Current and Future Electrical Needs

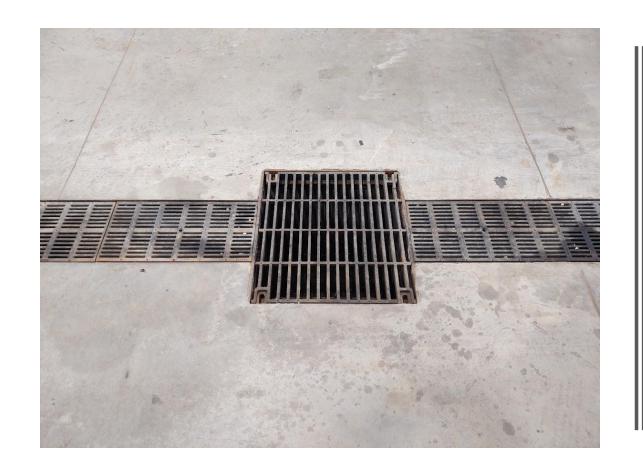
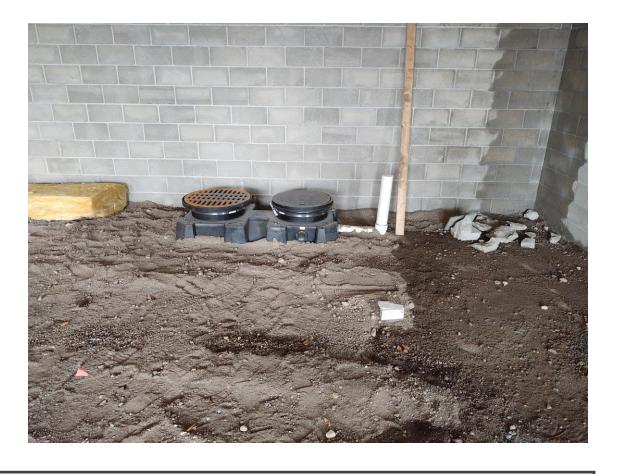
Sand Separator and Heel Proof Grates in Shop

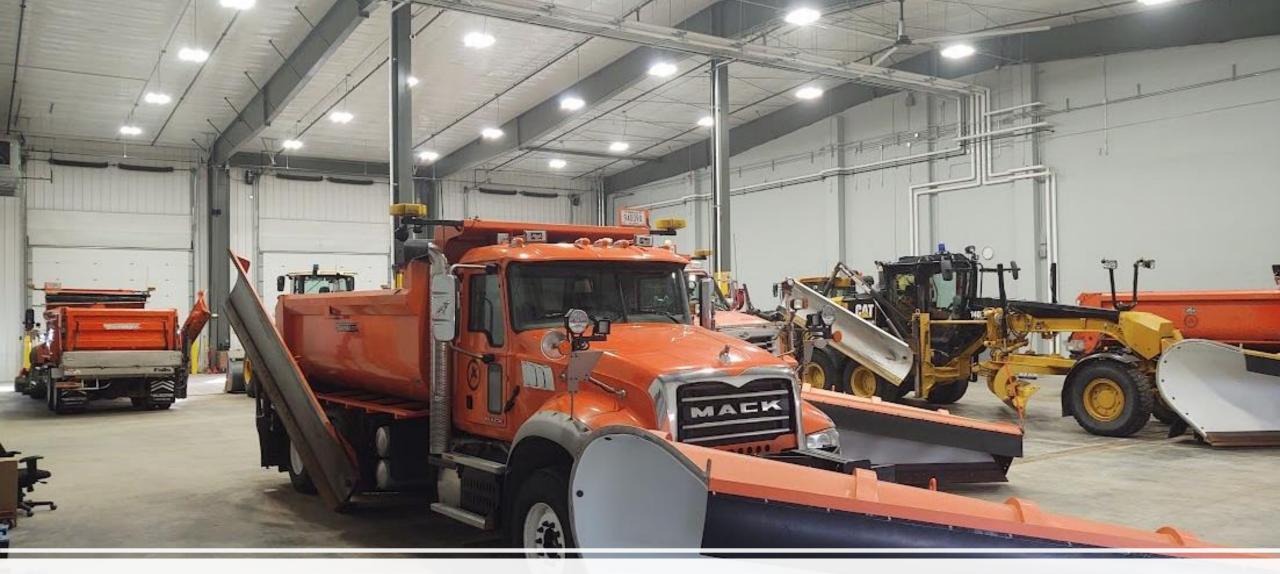
Big Stone Warm Storage 90' x 140'

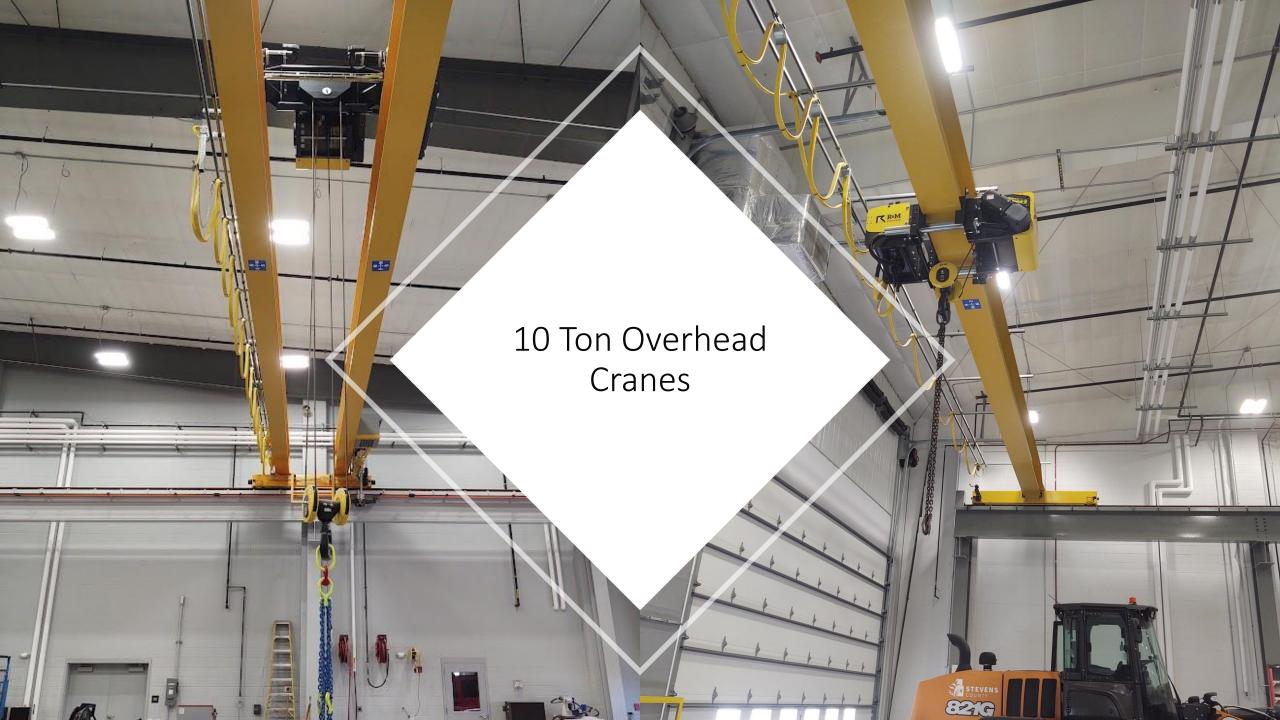
Water, Air and Electrical Reels
Throughout
Shop
